Barbara Helizanowicz^{1,2*}, Damian Helizanowicz², Łukasz Krzemiński³, Grzegorz Matula³

USE OF COMPUTED TOMOGRAPHY TO ASSESS QUALITY AND STRUCTURE OF CURVED CFRP LAMINATE SAMPLES PRODUCED BY AUTOCLAVE TECHNOLOGY

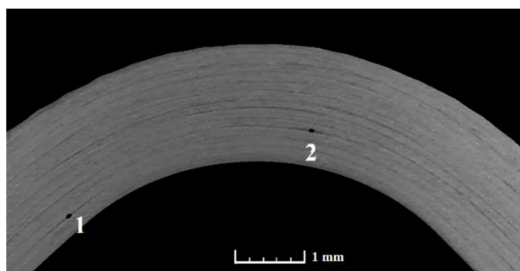
The general information about the structure based on the CT scans is that the manufactured specimens were characterized by good quality with small distances between the plies, filled with resin and no porosity. However, a few types of defects were detected. One of them was interlayer voids, which are visible as black spots (Fig. 3). Only a few voids were detected in two of the examined specimens (both in the TP and SP specimens of the same geometry – 90° angle and 4 mm inner radius, which is the sharpest shape of all the curved beams). The dimensions of all the detected voids were measured employing ImageJ software, and in each case their size was smaller than the single ply thickness.

Fig. 3. Interlayer voids detected in SP specimen with 90° angle and 4 mm inner radius (dimensions: 1 – 0.085 mm x 0.043 mm; 2 – 0.091 mm x 0.051 mm)

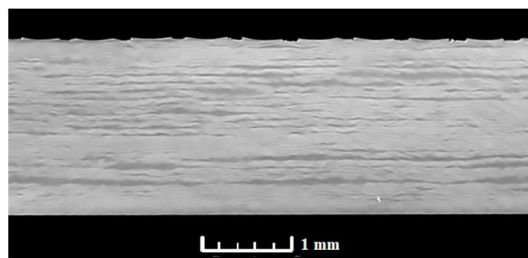
Another issue detected in the CT images were foreign objects between the layers, visible as white spots (Fig. 4). Their possible source might be residuals of the release foil, silicone paper or other process component remains which adhered to the prepreg during lay-up, but based on the CT scans it was not possible to define their origin. The dimensions of the detected objects were measured by means of ImageJ software and their size was smaller or similar to the single ply thickness, which means that they might have been difficult to notice and remove during the layup.

Fig. 4. Foreign object detected in TP specimen with 90° angle and 4 mm inner radius (dimensions: 0.049 mm x 0.028 mm)

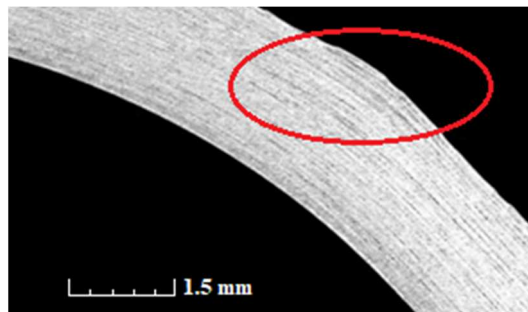
After the curing in the autoclave, some wrinkles appeared on the outer surface of the curved regions of the specimens listed in Table 2. The performed CT scans enabled us to take a look inside the wrinkles. In most cases, the wrinkles were rather superficial with a depth negligible compared to the sample thickness and affected only a single or a few outer layers (Fig. 5). Based on the CT images, it was also noticed that the wrinkles were more severe in the TP specimens than in the SP ones – the number and depth of wrinkles were higher in the case of the thin ply (Fig. 6).

Fig. 5. Wrinkle on outer surface of TP specimen with 90° angle and 12 mm inner radius

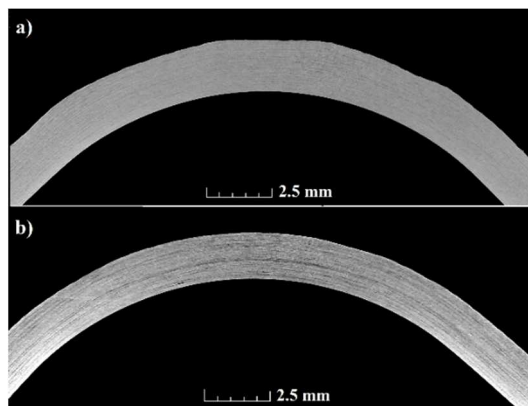
Fig. 6. Comparison of wrinkles present in specimens with 90° angle and 36 mm inner radius: a) TP specimen, b) SP specimen

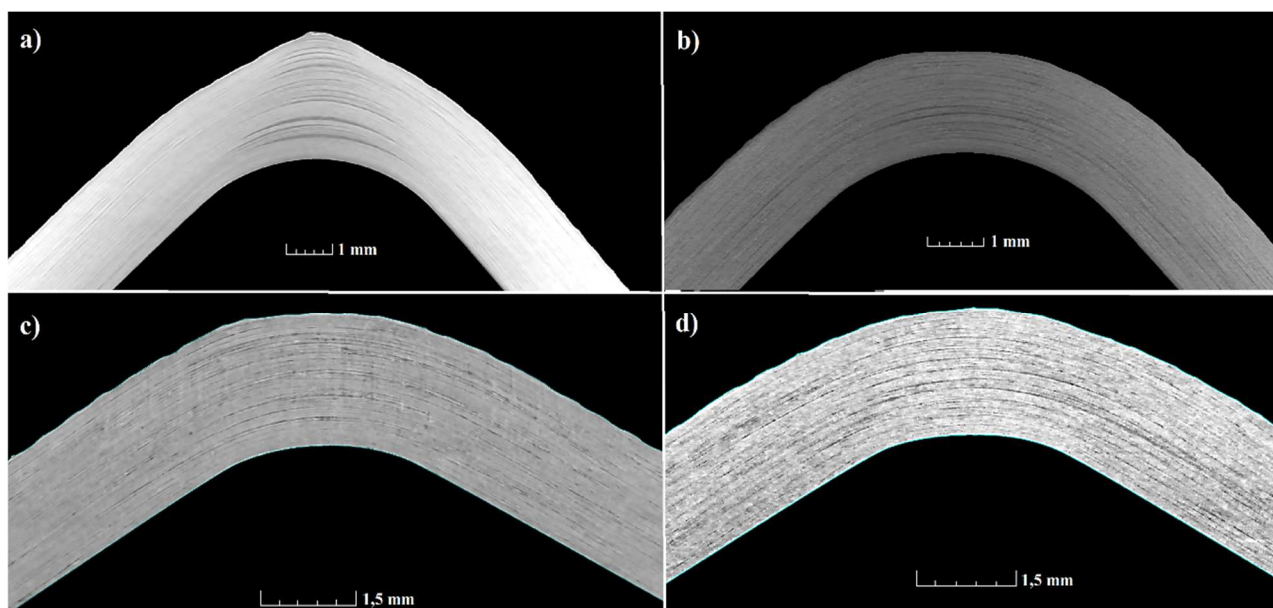
The next issues revealed by the CT scans were the greater distances between the adjacent layers around the curvature in the curved beams with the 4 mm inner radius. This phenomenon was severe in the specimens with the 90° angle and slightly visible also in the specimens with the 120° angle. Resin rich areas occurred between the layers. Regions with greater amounts of resin occurred in the TP specimens, as shown in Figure 7. The CT micrographs also allowed easy detection of a change in thickness in the curvature and determination of its nature. The change in thickness is visible in Figures 6 and 7.

The results confirm that enlarged interlayer regions are the highest for the 90° specimens. Another observation is that in each case the distances are higher for the TP specimens than in the SP ones although on the CT scans the microstructure seems to be more uniform for the TP specimens as the interfaces of the particular layers are less clear.

The larger distances between the adjacent layers in the TP specimens are probably caused by a higher resin content in the raw prepreg material. Better visibility of the interfaces between the layers in the SP specimens may be a result of the higher bending stiffness of the prepreg material, which caused less deformation of particular layers [34]. Nevertheless, the contrast and resolution of the scans may also influence this phenomenon. The TP specimens have a doubled number of plies, hence higher resolution may be required to clearly visualize the interlayer interfaces. Low contrast between the resin and fibers is also a known problem in the X-ray CT of CFRP composite laminates due to the small difference in the attenuation coefficient [31].

Fig. 7. Resin rich regions between layers around curvature in specimens: a) TP with 90° angle and 4 mm inner radius, b) SP with 90° angle and 4 mm inner radius, c) TP with 120° angle and 4 mm inner radius, d) SP with 120° angle and 4 mm inner radius
