Barbara Helizanowicz^{1,2*}, Damian Helizanowicz², Łukasz Krzemiński³, Grzegorz Matula³

USE OF COMPUTED TOMOGRAPHY TO ASSESS QUALITY AND STRUCTURE OF CURVED CFRP LAMINATE SAMPLES PRODUCED BY AUTOCLAVE TECHNOLOGY

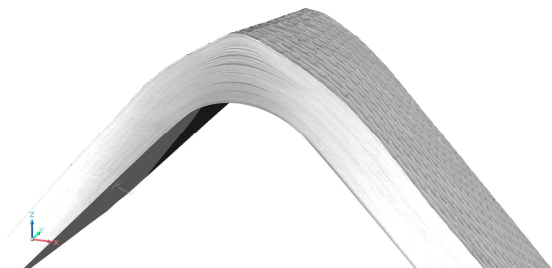
Fig. 2. 3D visualization of curved beam structure: TP specimen with 90° angle and 4 mm inner radius

The general information about the structure based on the CT scans is that the manufactured specimens were characterized by good quality with small distances between the plies, filled with resin and no porosity. However, a few types of defects were detected. One of them was interlayer voids, which are visible as black spots (Fig. 3). Only a few voids were detected in two of the examined specimens (both in the TP and SP specimens of the same geometry – 90° angle and 4 mm inner radius, which is the sharpest shape of all the curved beams). The dimensions of all the detected voids were measured employing ImageJ software, and in each case their size was smaller than the single ply thickness.
