Marcin Godzierz*, Anita Olszówka-Myalska

MICROSTRUCTURAL CORROSION EFFECTS ON CARBON FOAM-AZ31 MAGNESIUM MATRIX COMPOSITE SURFACE

In the article, a new composite was studied as a potential biomaterial. The effects of the interaction of distilled water with the polished surface of an AZ31 magnesium matrix composite reinforced with open-celled glassy carbon foam fabricated by the pressure infiltration method were investigated. The experiment was conducted in the time range of 1 minute - 4 hours and the microstructure was examined by scanning electron microscopy. In the initial unetched material, at the glassy carbon-metal interface, a zone of needle-like phases was detected. After a 1÷10 minute interaction with the water, disintegration of that zone was revealed and that type of material degradation proceeded deeper into the composite as the time increased. Another type of corrosion was observed in microareas of the magnesium alloy matrix, but only after approx. 1 hour when corrosion pits were recorded. The results of X-ray mapping showed an increase in the oxygen concentration in both types of corrosion products, but the reason for the corrosion in the region between the carbon fo

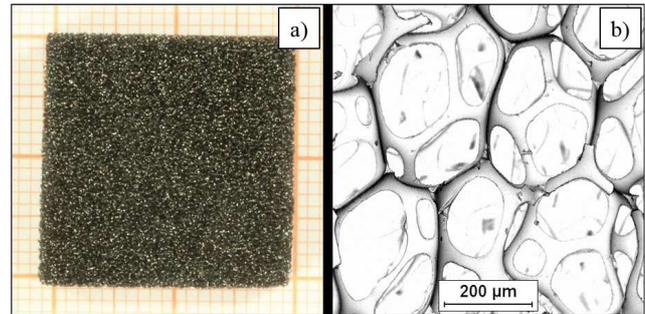
Fig. 1. Macrograph (a) and SEM micrograph (b) of 100 ppi open-celled carbon foam, fabricated by Duocel company

The composite was fabricated from the AZ31 alloy, of the composition presented in Table 1 and a carbon open-celled foam 100 ppi, manufactured by the Duocel company, denoted as C_{of} . The macrostructure and microstructure are shown in Figure 1. The applied C_{of} of 97% porosity consists of regular cells with windows facilitating liquid metal transport and characteristic band-like shaped walls, and that foam is also called reticulated vitreous carbon (RVC) in the literature. The process of component consolidation was conducted according to patented procedure [20] in vacuum atmosphere at the temperature of 690°C for 5 minutes with the maximal pressure of 5 MPa. The application of additional pressure was necessary because our earlier examinations of carbon foams and liquid magnesium as well as some magnesium alloys [33] showed ineffectiveness of the self-infiltration technique for component

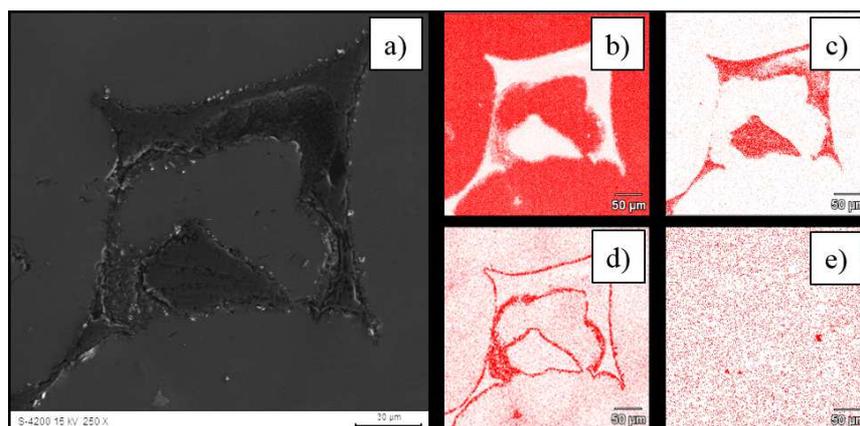
Fig. 2. SEM micrograph of as manufactured C_{of} - AZ31 composite surface (a) and X-ray elemental mapping of: magnesium (b), carbon (c), aluminium (d) and oxygen (e)

The results of the microstructure examination by SEM with EDS are shown in Figures 2-7. The observations of the composite microstructure just after pressure

infiltration presented in Figures 2 and 3 revealed C_{of} well filled by the AZ31 alloy and continuous bonding between the components with the absence of noticeable micropores. However, they also revealed two characteristic effects: a zone of needle-like phases was formed at the interface and microdestruction of mainly the carbon foam edges occurred. The EDS mapping results obtained both at lower (250x, Fig. 2) and higher (2000x, Fig. 3) magnification revealed the presence of aluminium and probably magnesium, as well as the absence of zinc and manganese in the areas with needle-like phases. In that system, the presence of intermetallic phases typical of the AZ31 magnesium e.g. Al12Mg17 alloy, could not be excluded, because they can crystallize in the interface region during composite processing [36, 37]. Nonetheless, they can be too fine to be detected by the EDS resolution and their presence can be confirmed only by several diffraction patterns (SADP) in transmission electron microscopy (TEM). The signal of oxygen's characteristic radiation was not recorded in the interface zone either, but that is understandable because of the nanometric thickness of the oxide layers characteristic of magnesium matrix composites [4, 37].

when we compare Figures 2 and 7. In the corroded sample, besides degradation of the interface region, new light irregular phases are visible in SEM, and the EDS results show a high oxygen content with a decrease in the magnesium concentration, which suggests the formation of magnesium oxide or magnesium hydroxide. An increase in the experiment time to 4 hours entailed the growth of corrosion products and finally the effect of the metallic microareas being coated by new phases. Such changes in the AZ31 microstructure induced by corrosion in water are known and described in the literature [21-23, 25].

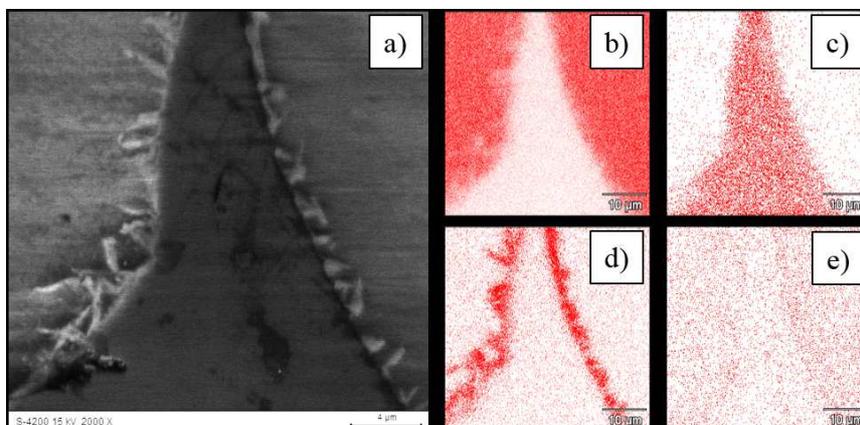
Fig. 3. SEM micrograph of as manufactured C_{of} - AZ31 composite surface, needle-like phases visible in interface region (a) and X-ray elemental mapping of: magnesium (b), carbon (c), aluminium (d) and oxygen (e)

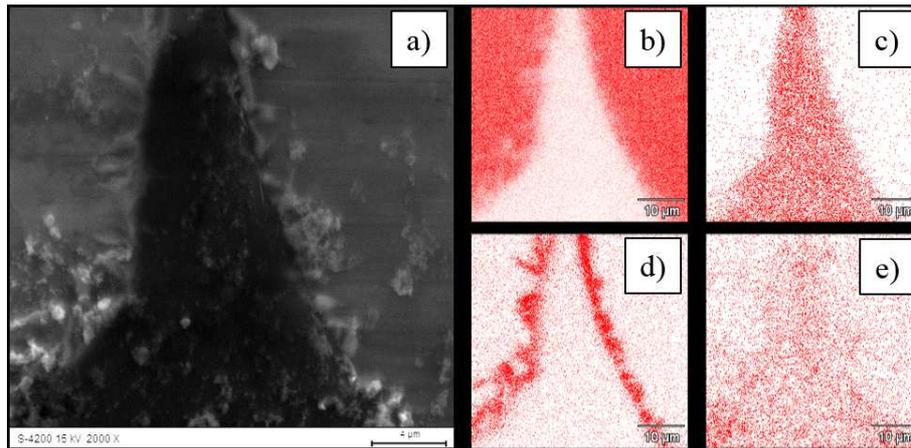
Fig. 4. SEM micrograph of C_{of} - AZ31 composite surface after immersion in distilled water for 1 min (a) and X-ray elemental mapping of: magnesium (b), carbon (c), aluminium (d) and oxygen (e)

The first changes in the C_{of} - AZ31 composite microstructure on the polished surface were noticed in the SEM micrographs after 1 minute of exposure to the distilled water (Fig. 4), but at the interface only. Minor degradation processes of the needle-like phase occurred and the formation of a new product was visible. In that region, EDS mapping, except for aluminium, reveals the presence of oxygen and it suggests hydroxide formation (Fig. 4e). Despite the microstructure evolution effect, the needle-like phases were still locally visible and it was characteristic that the growth of a new phase occurred over the polished surface. Additionally, the immersion tests of the composite were accompanied by the emission of gas smelling like methane.

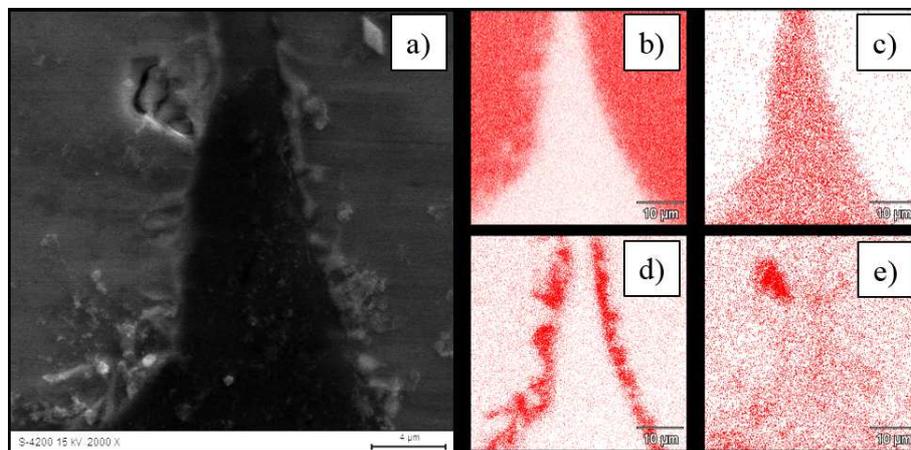
Fig. 5. SEM micrograph of C_{of} - AZ31 composite surface after immersion in distilled water for 5 min (a) and X-ray elemental mapping of: magnesium (b), carbon (c), aluminium (d) and oxygen (e)

Extending the exposure time in the water to 5 minutes induced (Fig. 5) microstructure changes similar to the ones observed earlier, and the increase in the characteristic radiation intensity of oxygen was measured through X-ray mapping (Fig. 5d). A further increase in the contact time of the composite with the water to 10 minutes (Fig. 6) caused changes in the shape of the observed phases without a significant increase in the X-ray radiation intensity of oxygen. It suggests the effect of hydroxide rinsing from the composite surface after subsequent sample immersion. Moreover, two issues must be mentioned. In the time range of 1-10 minutes, no corrosion effects were observed in the microareas of the AZ31 magnesium matrix, but some destruction at the C_{of} surface was detected. The reason for that second phenomenon is the diffusive mechanism of the growth of aluminium containing needle-like carbides, which occurs mainly in the matrix, but also in the carbon material.

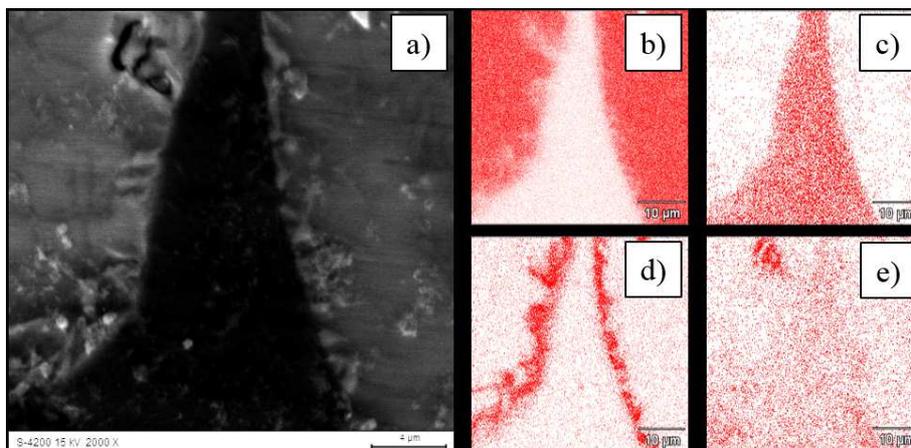
Fig. 6. SEM micrograph of C_{of} - AZ31 composite surface after immersion in distilled water for 10 min (a) and X-ray elemental mapping of: magnesium (b), carbon (c), aluminium (d) and oxygen (e)

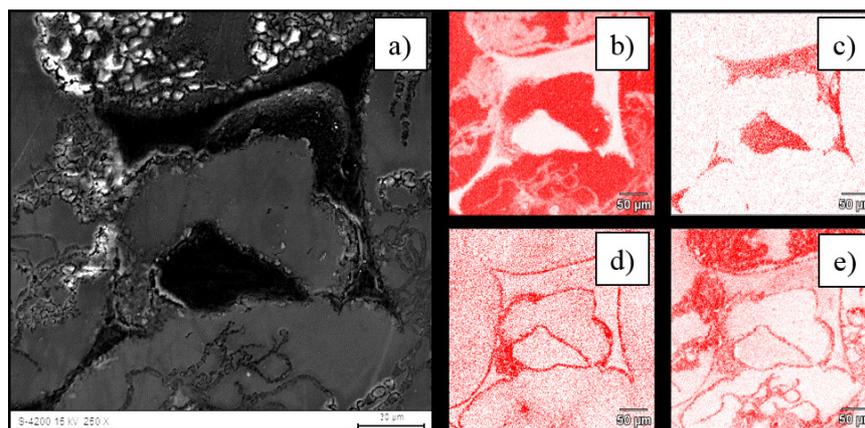
Fig. 7. SEM micrograph of C_{of} - AZ31 composite surface after immersion in distilled water for 1 h (a) and X-ray elemental mapping of: magnesium (b), carbon (c), aluminium (d) and oxygen (e)

When the time of composite immersion was increased to 1 and 4 hours, observation of the composite surface by SEM did not reveal any evolution of the C_{of} - AZ31 interface microstructure, and one may expect that all the hydrophilic phases had reacted with the water. However, after 1 hour, corrosion effects in the AZ31 matrix were evident, which is confirmed

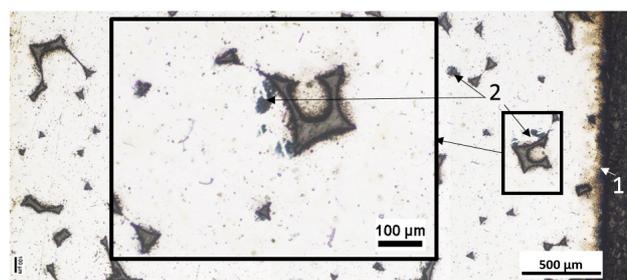
Fig. 8. LM micrograph of C_{of} - AZ31 composite, cross section after immersion in distilled water for 4 h, 1 - surface exposed to water, 2 - corrosion effects around carbon foam

The question that arises based on the microstructure changes observed at the composite surface is how deep their reach into the as-manufactured material is, and that problem is illustrated by Figure 8, which shows a cross section of the sample after a 4 hour test.

The effect of microstructure degradation at the C_{of} - AZ31 interface is observed up to 1000 μm in the composite depth and that exhibits the role of the carbon component geometry in the material degradation. A continuous foam facilitates access of the water to the inside of the composite, similar to the continuous car-

bon fiber preforms, but in contrast to dispersed reinforcing phases, such as short carbon fibers and glassy carbon particles. This process is similar to corrosion along the grain boundaries, well known in metallic materials. In the case of the AZ31 microareas in the examined composite, the layer of corrosion products formed at the surface was uniform and less than 100 μm , which means one order of magnitude less.
