**Adam Stawiarski\*, Stanisław Miarka, Marek Barski, Paweł Romanowicz**

*Cracow University of Technology, Institute of Machine Design, ul. Warszawska 24, 31-155 Krakow, Poland*

## FATIGUE DAMAGE DETECTION IN COMPOSITE PLATE WITH A CIRCULAR HOLE BY ELASTIC WAVE PROPAGATION METHOD

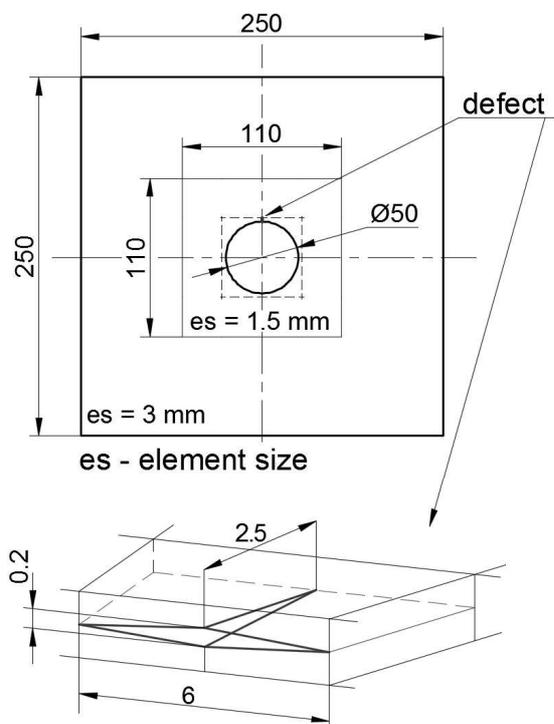
A composite multilayered plate with a circular hole in the middle is considered. The thickness of the plate is equal to 2 mm. The dimensions of the interlaminar defect on the edge of the hole are presented in Figure 1. The finite element ANSYS package has been used to evaluate the dynamic behavior of the composite structure. The 3D solid 186 finite element type with 20 nodes was used in modelling the structure. An appropriate finite element model of elastic wave propagation phenomenon has to satisfy several requirements. The mesh density features 8 nodes per wavelength. The time step for dynamic analysis is less than the ratio of the minimum distance of any two adjoining nodes to the maximum wave velocity. The laminate should be divided into sub-laminates in thickness to characterize individual laminae especially when we consider interlaminar delamination in a composite structure.

Fig. 1. Geometry of composite plate with circular hole and interlaminar fatigue defect

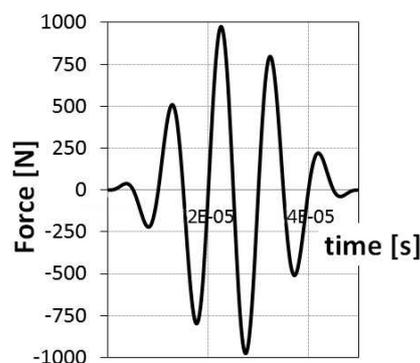
$$F(t) = \begin{cases} \frac{1}{2} F_0 \left[ 1 - \cos\left(\frac{2\pi f_0 t}{n_0}\right) \right] \sin(2\pi f_0 t), & t \leq \frac{n_0}{f_0} \\ 0, & t > \frac{n_0}{f_0} \end{cases} \quad (1)$$

where  $F_0 = 1000$  N defines the amplitude of the applied force and  $n_0$  is the number of wave packages. The form of the excitation signal is shown in Figure 2.

Fig. 2. Form of excitation signal

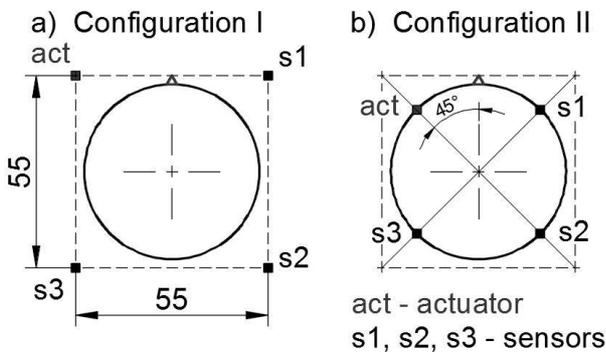
The efficiency of the damage detection system depends on the number and location of the actuator and sensors in the analysed area. In this paper, one actuator (act) generates the elastic wave which propagates through the structure and three sensors (s1, s2, s3) detect the dynamic response of the plate. Two configurations of measuring point locations have been proposed to verify the effectiveness of early detection of a small interlaminar defect (Fig. 3).

Fig. 3. Two proposed configurations of actuator and sensor location  
Rys. 3. Dwie konfiguracje rozmieszczenia aktywatora i sensorów

The first configuration (Fig. 3a) contains measuring points placed near the hole edge. The wave propagation path, understood as the shortest track connecting the actuator and sensor (s1), lay close to the defected area. The second configuration (Fig. 3b) contains the actuator and sensors placed directly on the hole edge. The elastic wave propagates along the hole edge passing through the damaged zone. The second configuration allow one to analyse the wave propagation without reflections from the boundary.

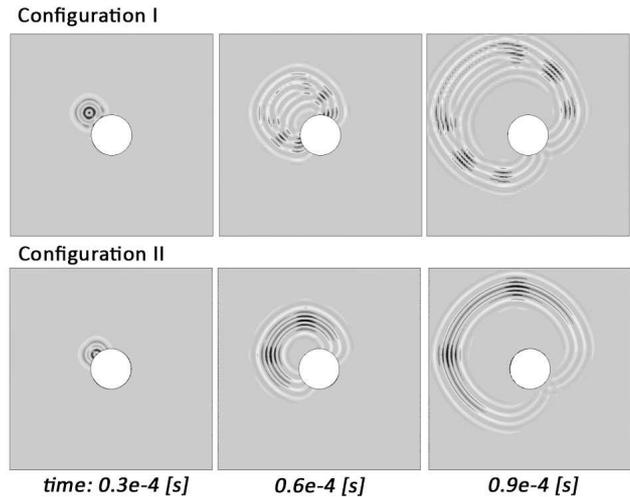
The basic assumption of the SHM system based on the wave propagation method is the comparison of a potentially defected structure with an intact one to observe the change in the dynamic response. In this paper, the pitch-catch measurement technique has been applied where the disturbance caused by the defect is analyzed. The reflections from the boundary and from the interlaminar defect are not taken into account. The view of the elastic wave fronts propagating through the structure in the composite plate demonstrates the importance of actuator location in dynamic response analysis (Fig. 4).

Fig. 4. Comparison of wave propagation for two configurations of actuator location

In the first case of configuration, where the actuator is placed at some distance from the hole edge, the reflections from the boundary affect the wave propagation and complicate the interpretation of appropriate sensor placement. To avoid such difficulties, a second configuration has been proposed where reflections from the boundary have been avoided. The direct comparison of wave propagation described as a normalized lateral displacement in the intact and defected structure allow one to determine the state of the structure. The results for the first configuration of sensors placement (Fig. 5) indicate that early detection of the interlaminar defect cannot be effective when the measuring points are distant from the hole. The signals from the structure with a small interlaminar defect are identical to those from the intact plate. The assumed small size of the defect is undetectable if the wave propagation path does not pass through the defected area. The reflections from the hole edge additionally complicate the elastic wave behaviour.

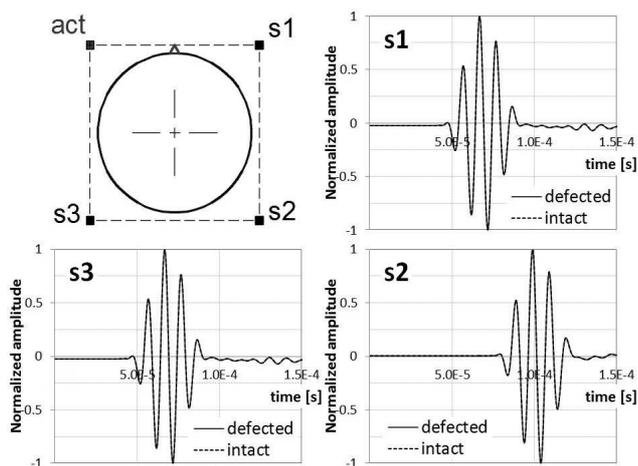
Fig. 5. Comparison of wave propagation for first configuration of sensor location

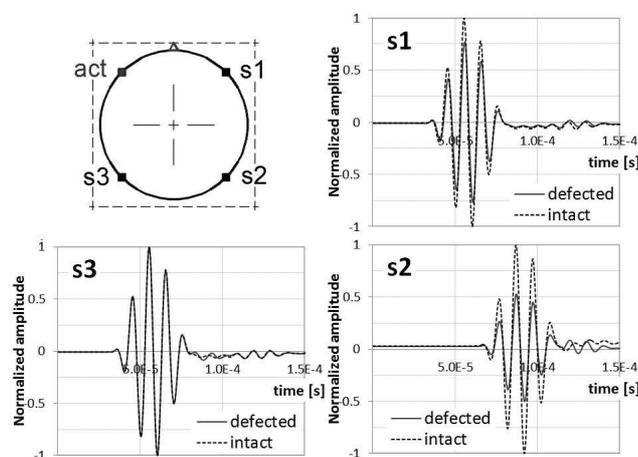
The second configuration of measuring points placement demonstrates the effectiveness of the damage detection process (Fig. 6).

Fig. 6. Comparison of wave propagation for second configuration of sensor location

The elastic wave excitation on the edge of the considered hole allows monitoring of the change in the signal caused by the defect. The significant difference between the signals from the intact and defected structure was observed by sensors s2 and s3 for which the wave propagation path passed through the defected zone. The relatively small interlaminar defect causes a change in the amplitude of the signals. The phase shift is negligible. A noticeable decrease in the amplitude indicates the fact that an interlaminar defect impairs the elastic wave but does not change the characteristic of the wave. This feature can be used by an automatic damage detection algorithm which processes the measured data into information about potential damage detection.
