Michał Sałaciński^{1*}, Paweł Orzechowski¹, Marek Chalimoniuk¹, Andrzej Leski²

ANALYSIS OF BONDING LAYER QUALITY IN REPAIR PROCESS OF AIRCRAFT COMPOSITE STRUCTURE AFTER IMPACT DAMAGE

Keywords: bonding, composite repair, impact damage, porosity, computed tomography

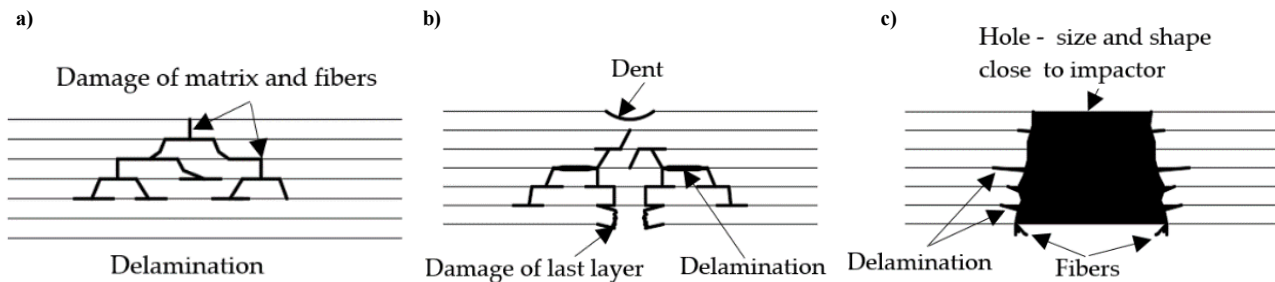
Fig. 1. Impact damage of epoxy-carbon composite (CFRP): a) low energy impact damage; b) medium energy, low speed impact damage; c) high energy, high speed impact damage

Typical damage of laminar structures is caused by impacts of various energies. Damage in the scientific sector is classified according to the impact energy and velocity of the impactor [1-5], as schematically shown in Figure 1.

from small birds. During maintenance this type of damage can also occur. It can be caused by the impacts of tools such as small wrenches or screwdrivers [6]. Upon this definition and the results of a radiogram presented in [6], it can be assumed that this type of damage is characteristic of low energy impact damage (Fig. 1a).

Barely visible damage, which may not be found during HMV (heavy maintenance general visual inspections), is not visible to the unaided eye under normal light conditions from a distance of about 1.5 m. This sort of damage occurs when hitting up to approximately 135 J with a 25.4 mm diameter semi-spherical impactor. In operation, such energies are characteristic of impacts caused by foreign objects or fragments of the runway during take-off and landing. During maintenance such damage can also occur, caused by the fall of large tools such as large wrenches, a hammer or a pneumatic drill [6]. Considering this definition and the results of the radiogram presented in [6], it can be assumed that this type of damage is characteristic of medium energy low speed impact damage (Fig. 1b).

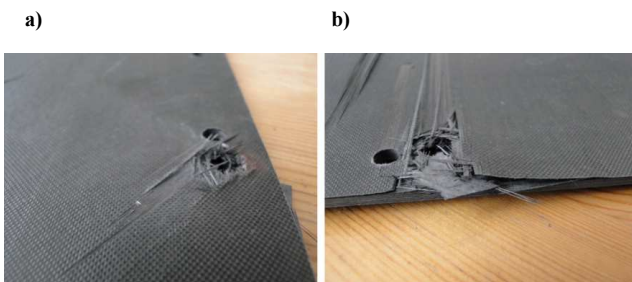
Fig. 2. Damage caused by high energy high speed impact: bullet hole (M4 carbine, caliber 5.56 mm) in specimen (40 layers unidirectional quasi-isotropic): a) entrance; b) exit

Visible impact damage (VID) above 135 J is damage detectable to the unaided eye under normal light conditions from a distance of about 1.5 m. Standard damage is also done with a 25.4 mm diameter semi-spherical impactor. In operation, such energies are primarily impacts of large birds or during collisions with other objects during taxiing. During maintenance, this type of damage is typically caused by accidental impacts of a hammer or other heavy tools. VID includes damage caused by high energy and high speed impacts (Fig. 1c). This damages concern mainly military aircraft and takes place during missions – also called battle damage [7], as shown in the example in Figure 2. This includes mainly bullet and shrapnel impacts.

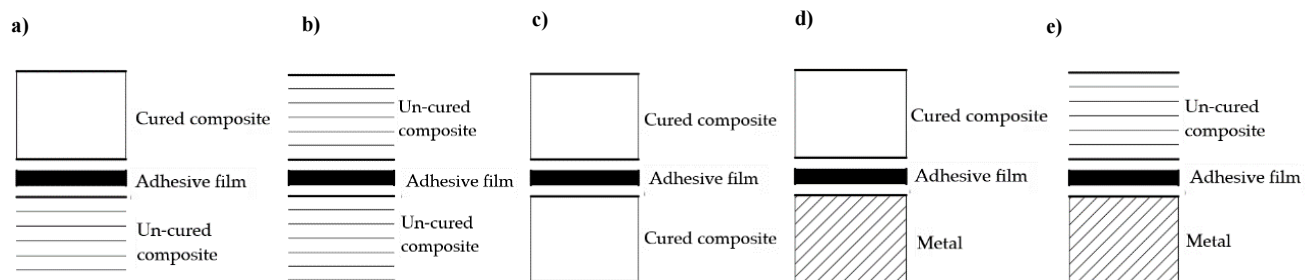
Fig. 4. Models of typical manufacturing bonding processes between composite components: a) co-bonding; b) co-curing; c) secondary bonding, d) and e) multi-material bonding

Structure strength properties. The structure can be restored during repair in several ways [10]: co-bonding, co-curing, secondary bonding and multi material bonding. The concept drawings of bonding are presented in Figure 4.

According to reference [11], a composite repaired with the scarf structure restoration method (Fig. 3a) and by means of secondary bonding (Fig. 4c) regains over 90% of its undamaged properties. This method is the most effective one used to date. The effectiveness of the method results from the fact that the composite patch is made in prepreg technology with the autoclave method and then the patch is bonded with the damaged structure using adhesive film. The autoclave method allows us to produce the composite patch in the same conditions as the original structure.

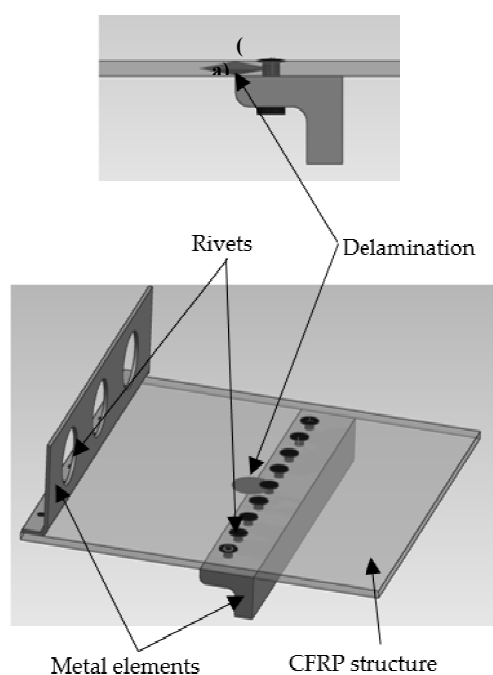
Fig. 5. Model of aircraft structure with impact damage delamination

A model of a fragment of a classical structure with damage is presented in Figure 5.

The assembly and sealing of a vacuum bag on a large irregular surface is complicated, by rivets, overlapping joints or other openings, such as those presented in Figure 5, making this task much more complicated than for a simple laboratory sample. In addition, the resulting damage usually occurs across the entire cross-section of the structure, which requires a through-hole. Therefore, a problem occurs with sealing the hole from the other side of the repaired structure, which is inaccessible. A model of such repair is presented in Figure 6.

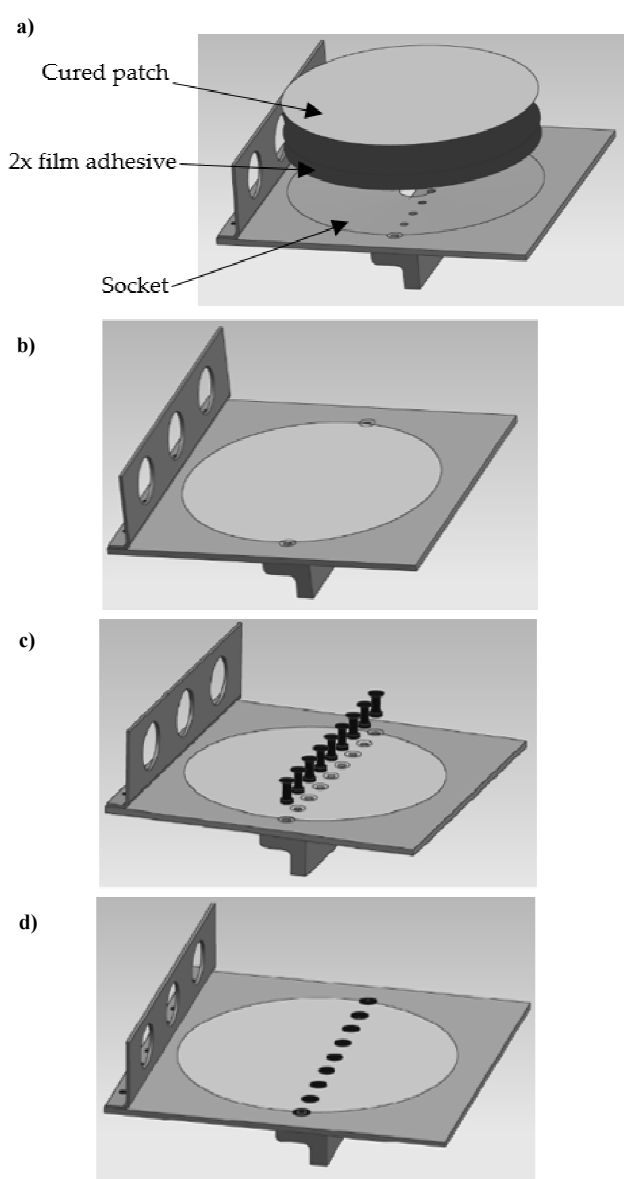
Fig. 6. Model of damage repair across section whole skin thickness: a) repair area and repair components, b) structure after curing adhesive films; c) riveting; d) structure after repair

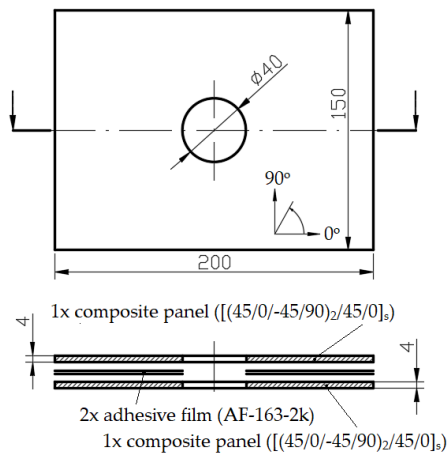
Fig. 7. Diagram of tested sample

The thickness and the porosity of the bond after hardening between two composite panels was analyzed (Fig. 7).

The panels were created in the form of laminar composites with a quasi-isotropic structure $[(45/0/-45/90)_2/45/0]_s$. Each panel was composed of twenty 0.16 mm layers of E722-02 HS-14 12K 130g 35%rw

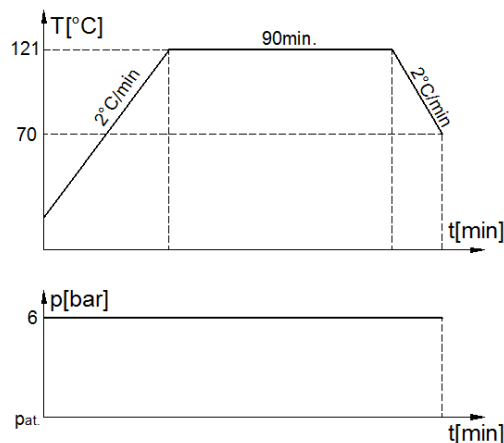
Fig. 8. Cure cycle of composite panels

600 mm carbon epoxy UD prepreg material manufactured by TecCate. The curing cycle of the panel (Fig. 8) was conducted in an autoclave using aerospace technologies [1]. In total, eight panels were manufactured.

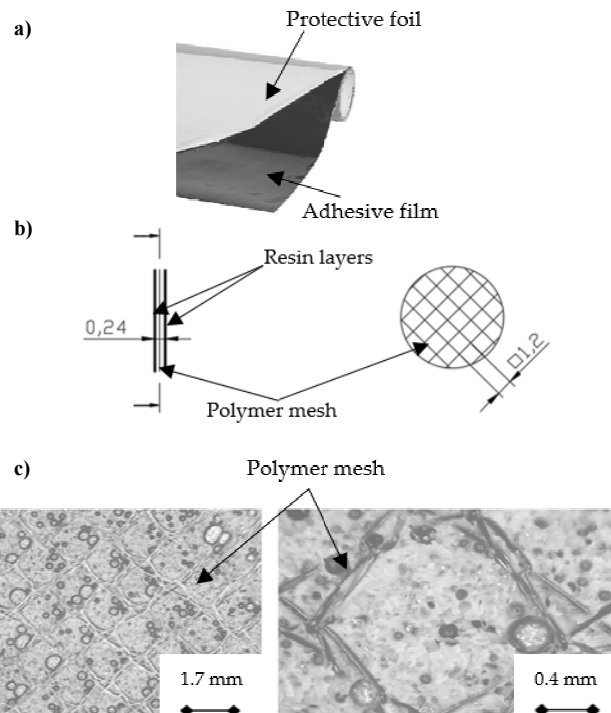
Fig. 9. 3M AF-163-2k adhesive film: a) uncured view; b) film construction; c) view of film after separation of adherent elements

The bond between the panels was made of two layers of 3M Scotch-Weld AF-163-2k (AF-163-2k) adhesive film. AF-163-2k adhesive film is commonly used in the aviation industry to bond metals and composites [15-17]. AF-163-2k adhesive film is stored at -18°C in its uncured condition. After unfreezing, the film is a flexible bonding layer. Flexibility and integrity are ensured by the resin applied to the polymer mesh (Fig. 9).

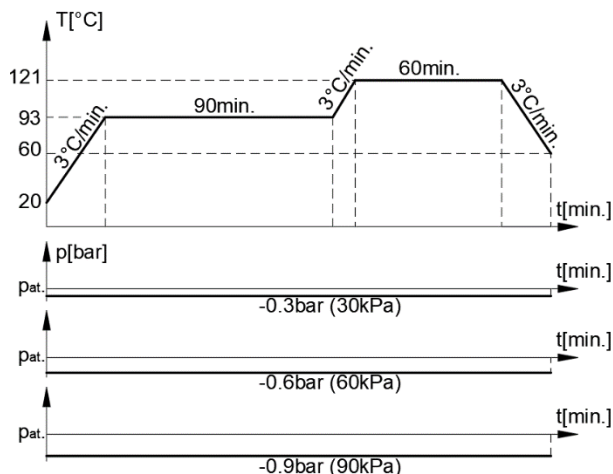
Fig. 10. Cure cycles of composite adhesive film

The curing cycle was conducted using an electronically controlled heating blanket and following the heat curve presented in Figure 10.

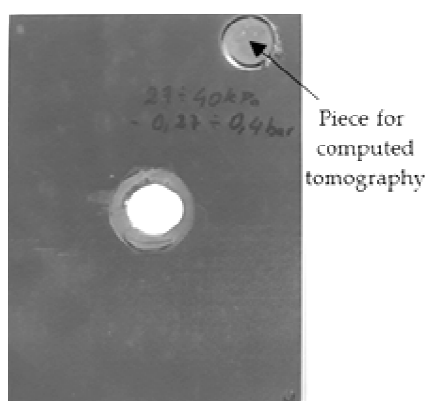
Fig. 11. Example sample after curing with leakage of adhesive film cured around hole

After the curing cycle of the adhesive film, a $\phi 25$ mm fragment was cut out of each sample for computed tomography testing, as shown in Figure 11.

The thickness of the bonding layer was measured on the pieces cut from the sample (Fig. 11). The thickness of the bonding layer was tested by CT (Fig. 13).

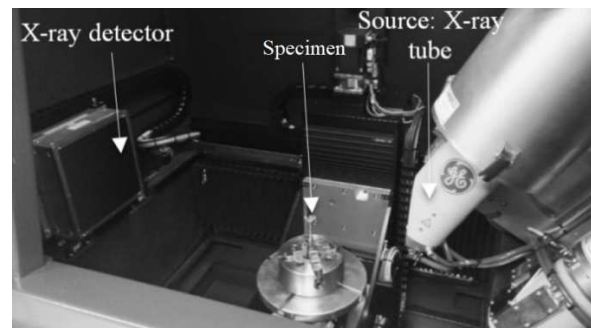
Fig. 12. Tomographic examination with panel detector – chamber of TC device during examination

The specimens were tested using a 300 kV lamp on a GE Phoenix v/tome/x m CT with a panel detector (Fig. 12). The tests were carried out with the following parameters:

- voltage 100 kV;
- current 100 mA;
- timing 333 ms.

A voxel size of $46 \mu\text{m}$ was obtained. 720 pictures were taken per full turn. The images were reconstructed on a graphic station using the Datos/x 2 program.

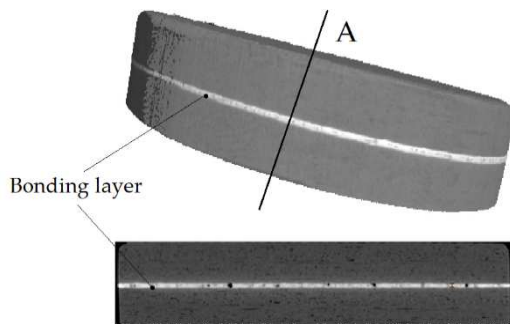
Fig. 13. Example of results of specimen (60h) tomography test, side view and cross section in plane A

The thickness of the bonding layer was measured in the VG Studio MAX 3.0 program with the "Caliper" measuring function. Six measurements were made for each specimen at various randomly selected locations. Next, the arithmetic average and standard deviation for individual specimens were calculated (Table 1).

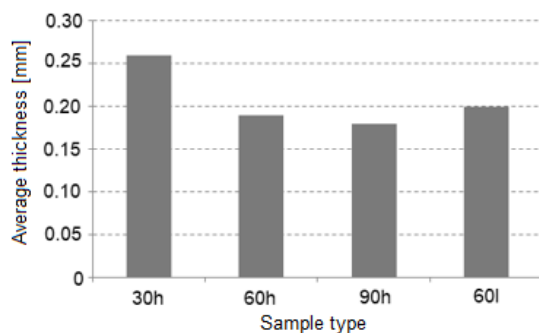
Fig. 14. Thickness of bonding layers

In order to facilitate comparison of the bonding layer thickness, a diagram (Fig. 14) was made on the basis of the measurement results and calculations (Table 1).

On the basis of the test results (Table 1 and Fig. 14), it can be concluded that the thickness of the bonding layer is dependent on the compressive pressure value. The thickness of the bonding layer is significantly higher when cured at the lower compressive pressure value of 30 kPa. At a higher compressive pressure value, although the difference in compressive pressure value is also 30 kPa, the difference in thickness is small. It should also be noted that at lower compressive pressure values the bonding layer is less even – the standard deviation is 0.04 mm.

The lack of tightness of the vacuum bag has practically no effect on the thickness of the bonding layer.

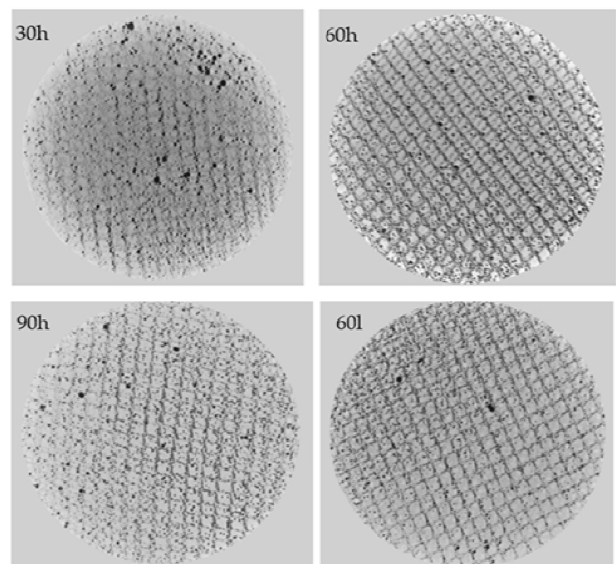
Fig. 15. Tomograms of bonding layers – cross-section made in plane parallel to glued layers in middle of bonding layer thickness

The percentage of porosity was determined by CT as well (Fig. 15), using the previously described phenomenon of radiation absorption by a higher density medium.

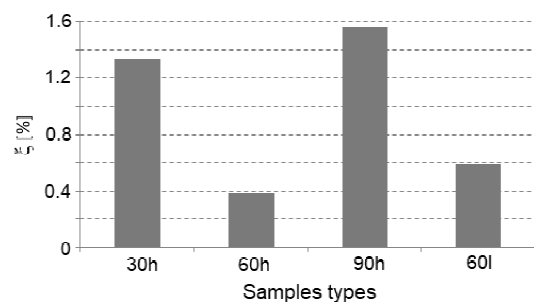
Fig. 16. Porosity level in bonding layer

In order to facilitate comparison of the porosity level of the bonding layer, a graph (Fig. 16) was made on the basis of the analysis results (Table 2).

Based on the results of the tests (Table 2 and Fig. 16), it can be concluded that the porosity level of the bonding layers depends on the compressive pressure value.

The above tests show that the porosity at the compressive pressure value induced by vacuum of -0.9 bar is higher than at the recommended -0.3 bar. Taking into account the results of the whole test, it can be assumed that the porosities of the 30h and 90h samples are at a similar level and are at an order of magnitude higher than the porosity of the 60h samples.
