Angelika Wronkowicz<sup>1\*</sup>, Krzysztof Dragan<sup>2</sup>

## DAMAGE SIZE MONITORING OF COMPOSITE AIRCRAFT STRUCTURES BASED ON ULTRASONIC TESTING AND IMAGE PROCESSING

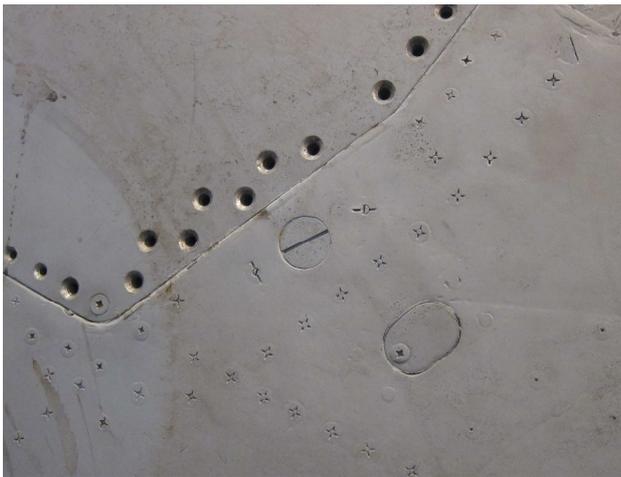
Fig. 1. Part of composite aircraft panel  
Rys. 1. Fragment kompozytowego elementu samolotu

In the research presented in this article, composite parts used in military aircraft were tested. As an exemplary structure, part of a CFRP KMU-4e: ELUR-0.1p and ENFB based on epoxy resin was chosen. The laminates were manufactured by stacking layers in the sequence 0,90,-45,+45. The thickness of the inspected specimen was equal to 4 mm. A demonstrative fragment of an exemplary tested element is presented in Figure 1. For ultrasonic inspection, an automated MAUS<sup>®</sup> device by the Boeing company was used. The system enables ultrasonic data (ToF and amplitude peak location) capture based on selected signal gates. The inspection results can be visualized in the form of C-scan mapping representing a chosen signal feature, e.g. the amplitude or ToF of a peak, with respect to the position of the ultrasonic probe. On this basis, damage

Fig. 3a) are not taken into consideration since they present attenuation in the adhesive layer and areas of the structure after disassembly of the elements (flaps and rivets visible in Fig. 1). The rest of the values are the other attenuation levels of the tested structure that may indicate the presence of a defect or damage, other elements embedded in the structure (e.g. unremoved rivets) or noise. These can be the areas of, among others, red, orange and yellow colours observable in Figure 4a. Since proper interpretation of C-scans is the task of a certified expert, the algorithm was intended to be semi-automatic. The analysis of C-scans cannot be performed without an expert since full automation of the algorithm may result in errors, which is unacceptable in the case of NDT in the aerospace industry. Namely, the initial removal of undamaged areas, based on the described plot, is performed automatically, then an expert indicates a ROI by drawing a polygon around the identified damage location and finally, additional post-processing is performed automatically again.

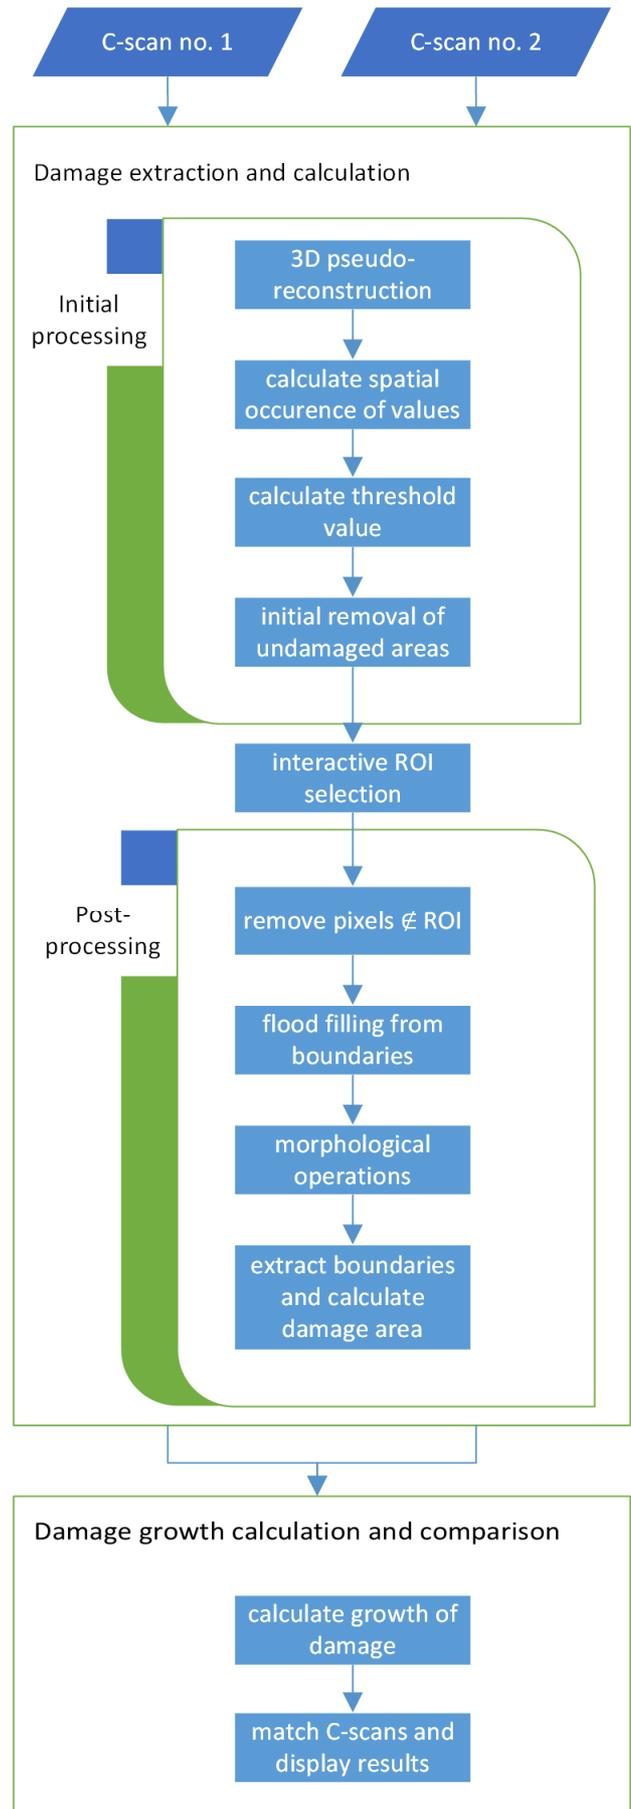
Fig. 2. Overall image processing algorithm  
Rys. 2. Ogólny algorytm przetwarzania obrazów

The generic scheme of the proposed algorithm, implemented in Matlab<sup>®</sup> with the use of the Image Processing Toolbox, is presented in Figure 2. The algorithm is divided into two main stages: damage extraction and calculation (which is performed separately on both input C-scans) and damage growth calculation and comparison (where the results of the first stage are analysed together). The consecutive steps are as follows.

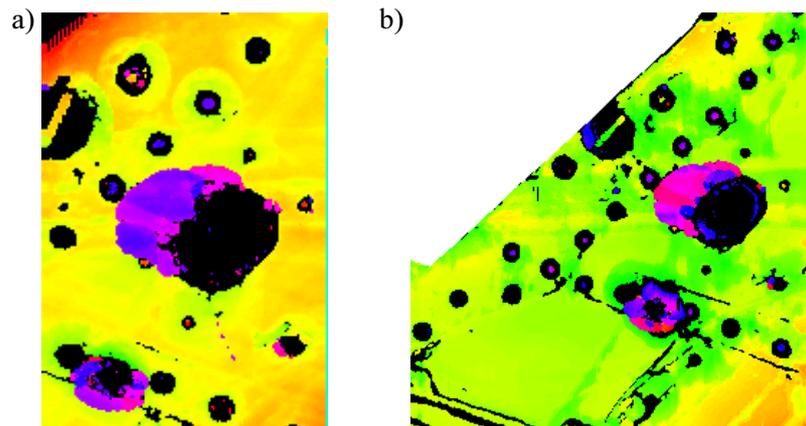
Fig. 3. Exemplary C-scans after UT performed in interval of two years

Firstly, a pair of C-scan maps in the form of 8-bit matrices is loaded into the workspace (see example depicted in Fig. 3). Then both of them, treated further as images, are individually subjected to the following operations (notice that the demonstrative results of these steps are shown based on the processing of one of the input images, namely Figure 3a).

The pixels with a value equal to and approximately 255 (seen as navy blue ones in Fig. 4a and black ones in

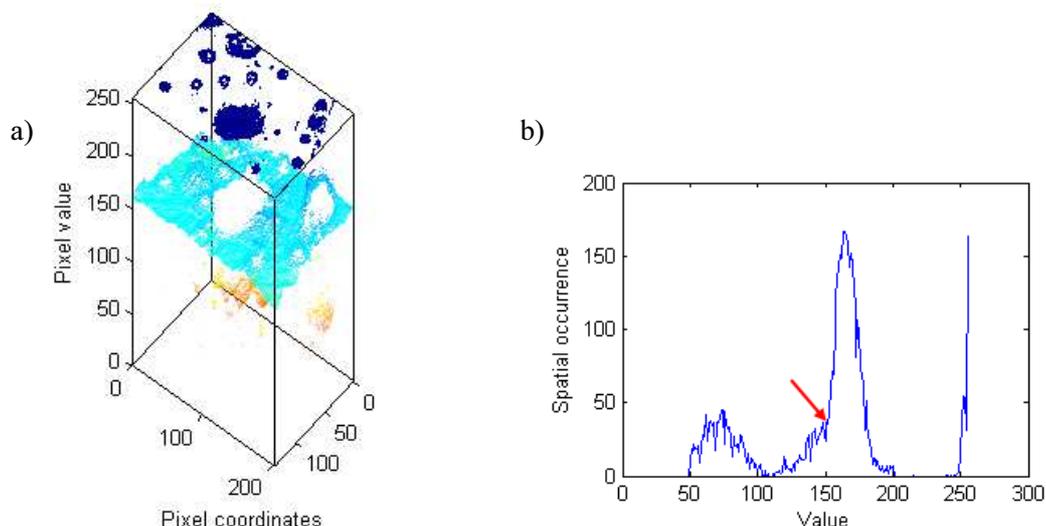
Fig. 4. 3D pseudo-reconstruction of C-scan presented in Figure 3a: a) 3D representation of values, b) plot of spatial occurrence of values

Firstly, for the purpose of initial estimation of a threshold for image segmentation, the following steps are performed. The image is 3D pseudo-reconstructed, i.e. the values of the 2D image are distributed to a 3D matrix, where each unique value lies on a level (layer) corresponding to this value (Fig. 4a). Then, the spatial occurrence of each value is calculated and plotted (Fig. 4b), which indicates how many times each value exists over the length and width, averaged, of each layer. The highest peak (global maximum) in Figure 4b indicates the values most widely distributed in the C-scan, thus it was assumed that it is expected to represent the proper (undamaged) regions of the structure (in Fig. 4a these are the areas with a cyan colour). If this assumption turns out to be incorrect in a particular case, an expert can correct the threshold value manually using the sliders and preview window of the results in the interface prepared for this algorithm.

Threshold  $T$  is selected automatically by detecting peaks in a plot (Fig. 4b) and then, by the developed loop algorithm, aimed at finding a point where the occurrence value stops drastically descending on the left side of the highest peak (such a desirable point is the local minimum indicated by the red arrow in Figure 4b).

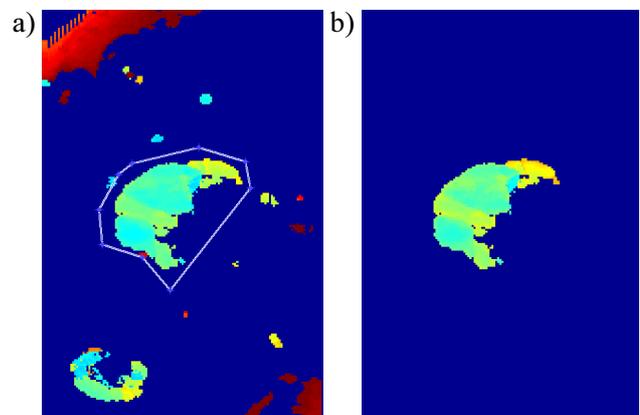
Fig. 5. Chosen image processing steps: a) selection of ROI, b) image before contour extraction

The next step is interactive and relies on selecting a region of interest (ROI) by the user (an expert) by means of indicating the points of a polygon around this region (Fig. 5a). Then, the pixels outside the selected ROI are removed (assigned to zeros).

is temporarily binarized in order to perform morphological area opening. This operation enables the removal of all the connected components that have fewer than the specified number of pixels from a binary image. The resulting image after this step is presented in Figure 5b. Finally, the boundaries of the resulting object (nonzero pixels) are extracted and its surface area is calculated. For the purpose of visually verifying if the damage extent was extracted properly, the boundaries around the detected region are displayed on the input C-scan. The resulting images are presented in Figure 6a and b, respectively, for the exemplary pair of C-scans (extracted contours are in magenta).

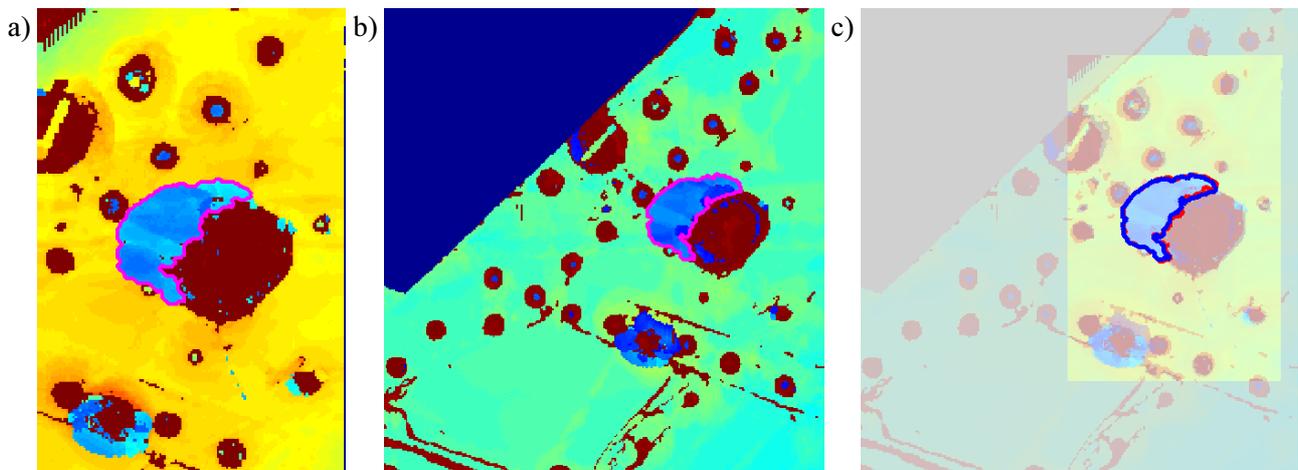
Fig. 6. Contours of selected damage: a) on 1<sup>st</sup> C-scan, b) on 2<sup>nd</sup> C-scan, c) superimposed contours

The second stage of the algorithm includes calculating the difference between the damage areas of both C-scans and superimposing both input C-scans with the detected contours onto one figure (Fig. 6c) based on the location of the centroids of these contours.

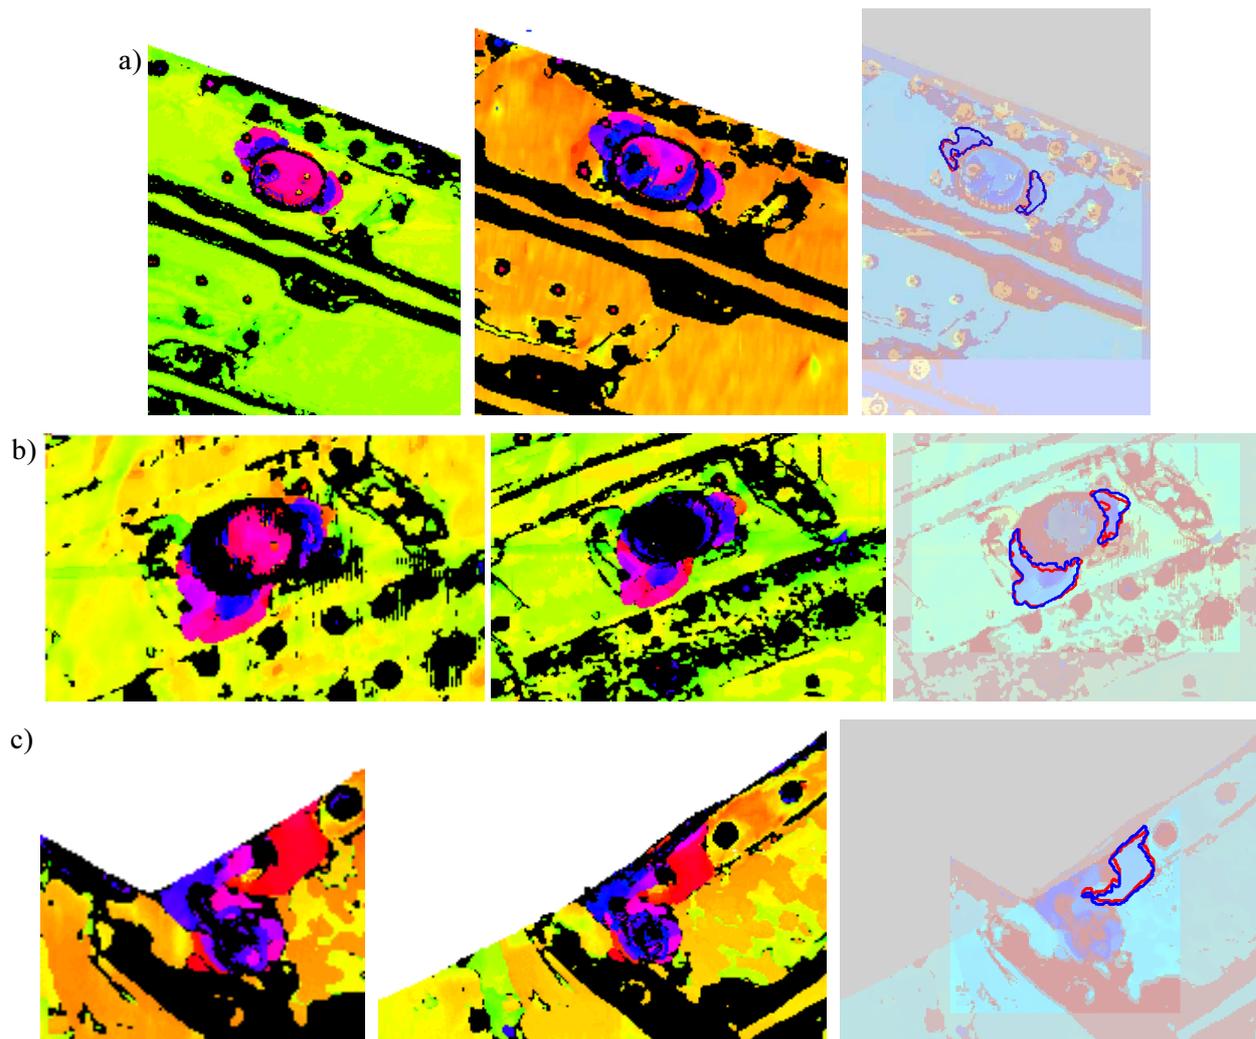
Fig. 7. Exemplary pairs of original C-scans and results of their damage extraction and comparison

The algorithm described above was tested and implemented on several pairs of C-scans described above and the exemplary results are depicted in Figure 7. Visual analysis of the results reveals that in all the cases the contours of the delaminations were detected properly. In the presented cases, the damage growth was calculated as follows: 0.4, 11.1, 2.05 mm<sup>2</sup> for the cases presented in Figure 7a, 7b and 7c, respectively, and -0.75 mm<sup>2</sup> for the demonstrative case presented in Figure 6. Obviously, damage growth cannot be negative, thus the last of the mentioned results follows from

either a measurement error, which must be taken into consideration during each NDT, or inaccuracy during image processing. One should be aware that the other results may also reveal certain measurement uncertainty, which is dependent on many factors, among others - the amount of couplant during UT or the presence of noise. Nevertheless, the obtained results show that image processing is very helpful in damage extent assessment and the developed algorithm may facilitate the diagnostic inference procedure. However, it should be recalled that final interpretation of the results and the decision about a potential repair should be made by an expert based on his experience.
