## POSSIBILITY OF USING EXPANDED PERLITE AS TEXTURISING AGGREGATE IN LIGHTWEIGHT POLYMER PLASTERS – IMPACT ON THERMAL AND MECHANICAL PROPERTIES OF COATING

**Keywords:** polymer plaster, lightweight fillers, expanded perlite, thermal insulation materials

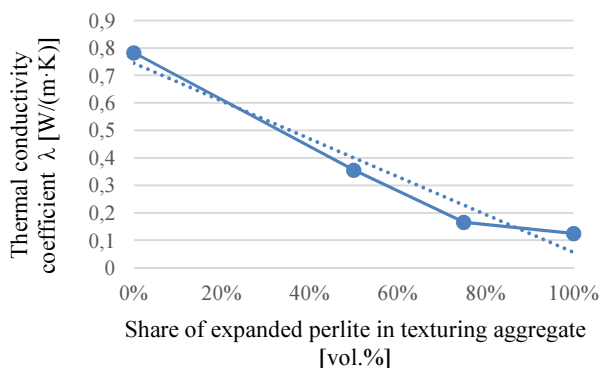
The presented relationship shows the significant impact of the light filler on the thermal insulation properties of the plaster mass. The sample in which perlite constituted 100 % of the texture filler had a thermal conductivity coefficient up to six times lower than the sample with the marble aggregate. It should also be

noted that as in the case of measurements of the density of the plaster masses, the relationship presented in the graph deviates from the linear relationship. The reason for this phenomenon may be the uncontrolled presence of air bubbles in the plaster binder mass. When a fillers with a large surface area are introduced into the mass, a significant amount of air trapped in the open pores is simultaneously introduced. Depending on the consistency of the mass, some of this air will escape to the surface. The remaining part will remain trapped in the mass. Thus, it may additionally contribute to changing the parameters of the plaster mass.

Fig. 2. Thermal conductivity coefficient determined for samples with different percentages of expanded perlite

The addition of a high porosity material contributed to reducing the total weight of the plaster mass. It was expected that the presence of numerous closed air bubbles would also contribute to improving the thermal insulation of the material. The results of the thermal conductivity coefficient measurements are presented in Figure 2.

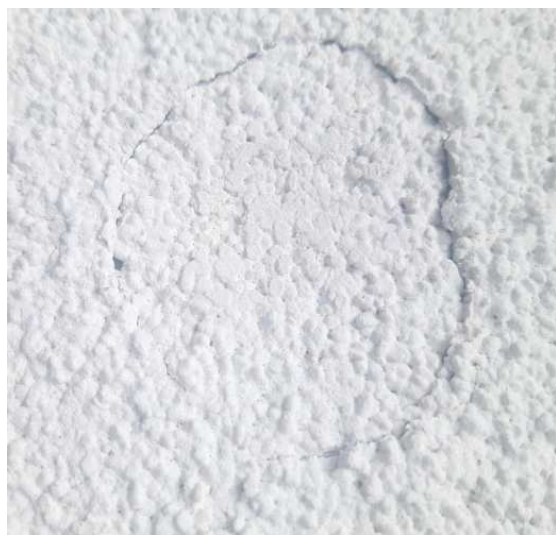
Interesting results were obtained for the sample containing only expanded perlite, for which, in addition to standard coating damage, a loss of structure resulting from crushing of the perlite aggregate was observed. This proves the low impact resistance of the filler itself. Figure 3 shows the coating after impact.

Fig. 3. Coating damage after hard body impact

In the case of all the plasters containing the expanded perlite, damage to the coating was already observed in the event of impact with the force of 3 J; cracks appeared on all the samples. With the increasing share of light filler, a larger dent diameter was observed. All the plaster samples containing expanded perlite were destroyed during impact with the force of 10 J. The samples containing 100 % and 75 % additionally penetrated the thermal insulation material. The diameter of the dents ranged from 45-55 mm. Greater uniformity in the diameter of the dents may be due to the limitation of the diameter of the ball employed during the test. The obtained results allow the conclusion to be made that the light plasters analysed in this study containing an admixture of expanded perlite meet the requirements of category III.

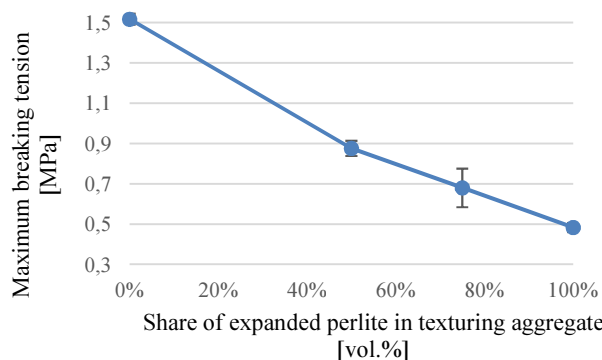
Fig. 4. Results of adhesion of samples to mineral substrate depending on content of expanded perlite

Plaster using only expanded perlite detached from the substrate at a stress three times lower (0.45 MPa) than the plaster with the standard aggregate (1.51 MPa). For the remaining samples, a proportional decrease in adhesion was observed with the increasing amount of expanded perlite admixture. The reasons for this phenomenon can be found in the reduced strength of the investigated fillers. The wettability of the substrate could also have deteriorated significantly as a result of replacing the aggregate with one with a greater surface area (open porosity of perlite). The observed effect could also be an indirect result of the consistency and rheology of the mass, which made it penetrate significantly worse into the porosity of the substrate.

The replacement of the marble aggregate with expanded perlite had a significant impact on the adhesion of the plaster mass to the substrate. Figure 4 presents the average values of the maximum breaking stress. Measurement of each mass was repeated three times.
